CONNECTICUT RIVER BASIN
NORTHAMPTON, MASSACHUSETTS

ROBERTS MEADOW RESERVOIR
(MIDDLE DAM)
MA 00761

PHASE I INSPECTION REPORT
NATIONAL DAM INSPECTION PROGRAM

AUGUST 1978

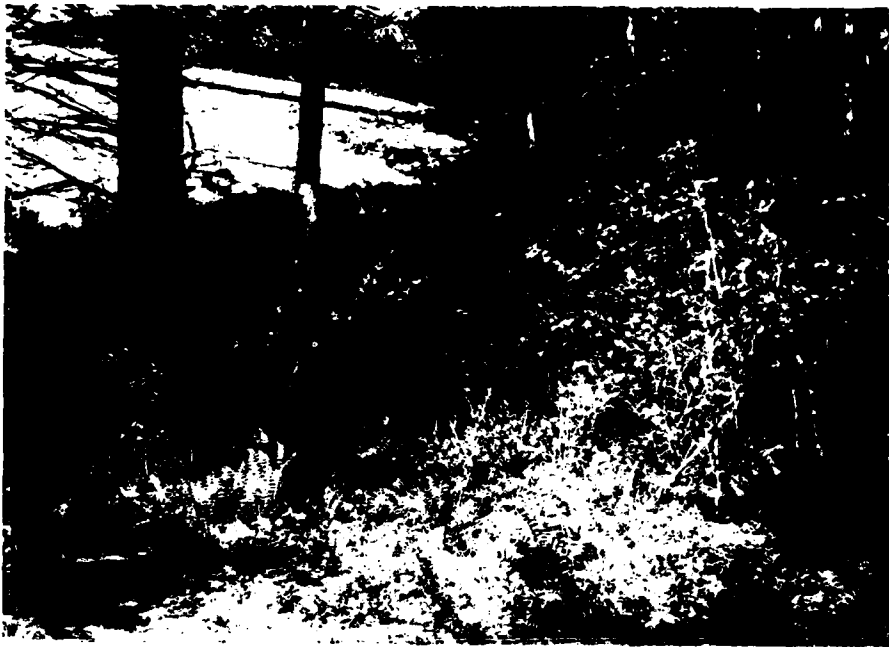
The left abutment was traversed from the dam face to the end of the spillway channel and two additional wet areas were noted at approximately the same elevation as the seep mentioned above. The second area, about 15 ft downstream of the first area, was damp but no surface water was visible. The third area was about 65 ft downstream of the dam face. This third area was very small with no surface water visible.

PHOTO NO. 3 - General view of seep area #2 on left abutment.

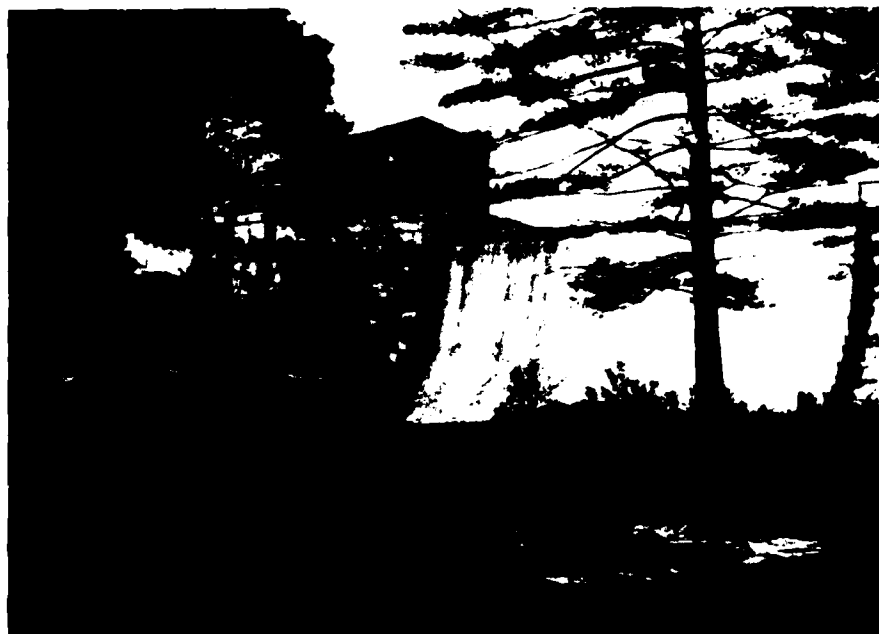
PHOTO NO. 6 - General view of outlet channel and
spillway.

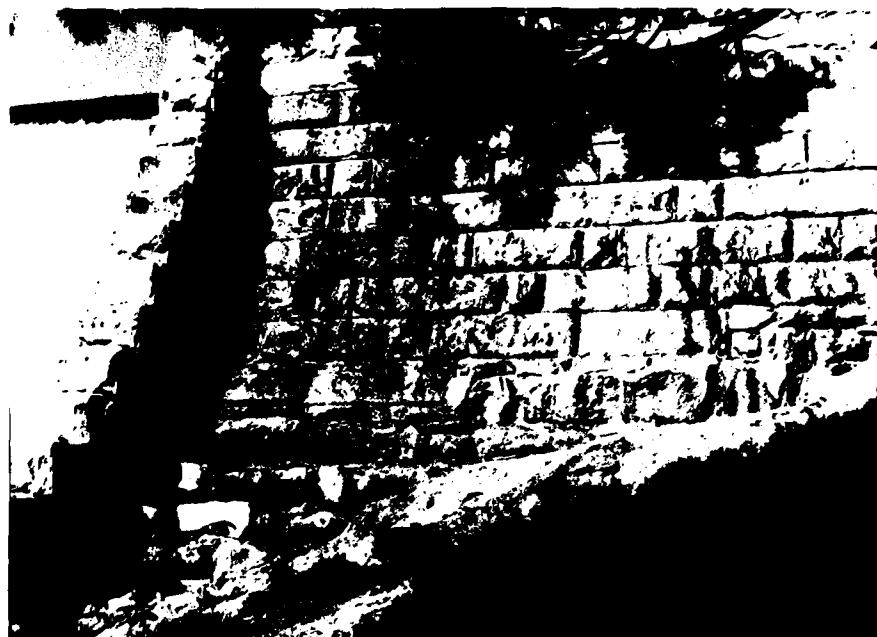
This dam was showing some leakage thru the mortar joints at the time of inspection. The dam has experienced heavy leakage in recent years and currently the City is attempting to have this leakage stopped. Section 4 of this report addresses in more detail the remedial action the city is undertaking.

PHOTO NO. 8 - General view of water seeping through left face of dam.

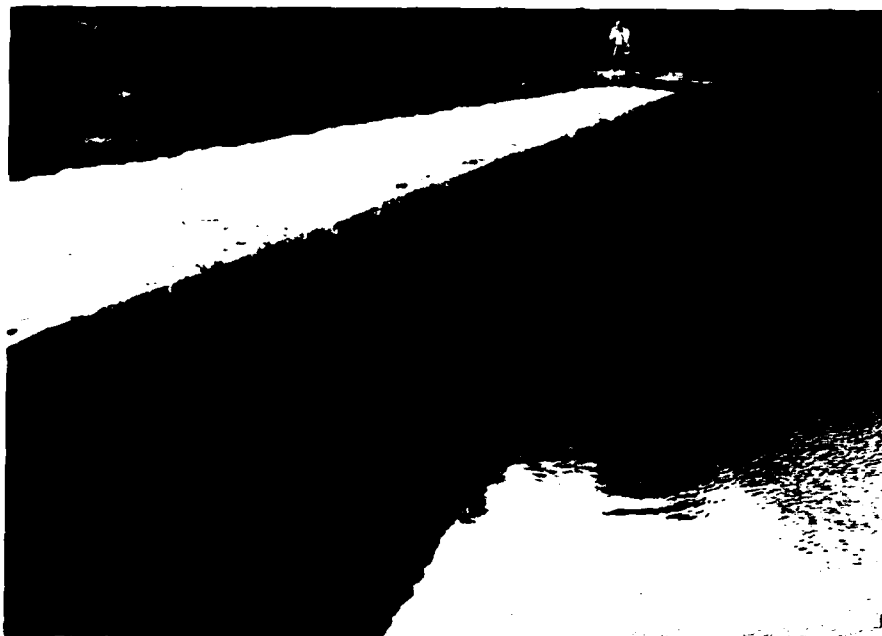
PHOTO NO. 11 - General view of upstream face left side of dam.

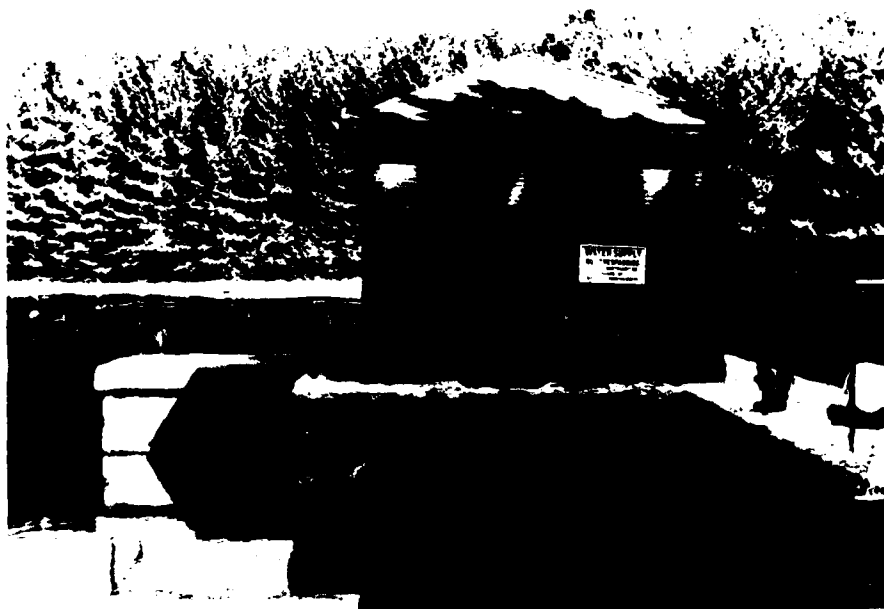
The gate house was inspected to the water surface. The house has a granite masonry substructure with a brick wall and wood roof superstructure. A concrete waste well attached to the rear of the gate house was added in 1933. A crack exists in the left rear corner of this waste well approximately 1/4 inch wide and extends down into the water. Some Spalling exist on the slab of this waste well. The east wall of the brick superstructure shows some cracking of the brick.

PHOTO NO. 12 - General view of Gate House.
